Opportunities of Identifying and Mapping the Soil Damage by Means of Digital Imagery

Ovidiu IACOBESCU,
Ionuț BARNOAIEA

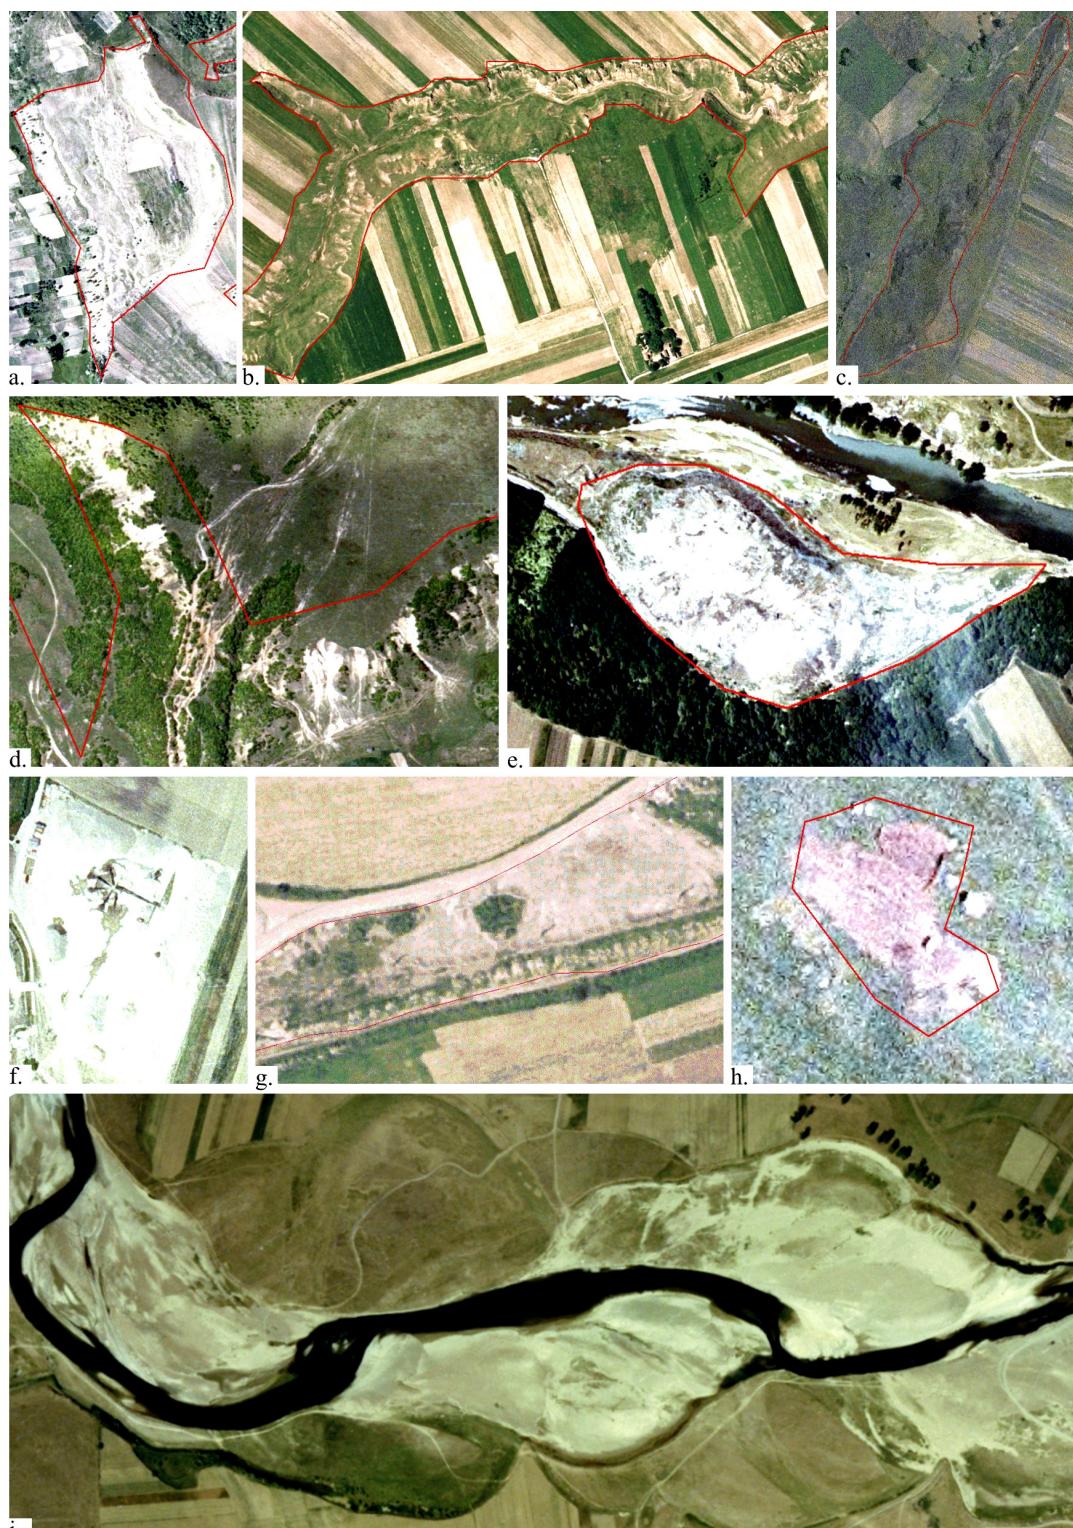
Fig. 1. Soil damage forms taken into account: a. wide area soil erosion; b. gully erosion; c. landslide; d. landslide with terrain collapsing processes; e. garbage deposits; f. gravel deposits; g. artificial land slopes; h. overgrazed zones; i. major waterbed of the Suceava River, with land movement phenomena present.

The criteria used for degraded soils identification is based on the specific geomorphologic characteristics of each type of degradation; an example for some of the soil damage forms encountered is presented in fig. 1. Each soil damage unit has been drawn in AutoCAD taking into account the entire area affected by the phenomenon; for example, the extension area of gully formations or ravines has been included in the polygon as damaged land due to the high evolution rate of the process (Hadley et al., 1985). On the other hand, all damage forms present in the major riverbeds have not been included in the study, considering the fact that these areas are subject to intense processes of alluviums transport, normal for these kinds of lands (fig. 1.i).

- **Erosion forms**, including gully erosion and wide area erosion (fig. 1.a and b.);
- **Landslides**, a phenomenon that can be accompanied by the collapsing of terrain (fig. 1.c and d);
- **Pollution affected lands**; in this case, there have been taken into account garbage disposing areas (fig. 1.e), gravel deposits (fig. 1.f), artificial slopes (fig.1.g) and overgrazed lands (fig. 1.h).

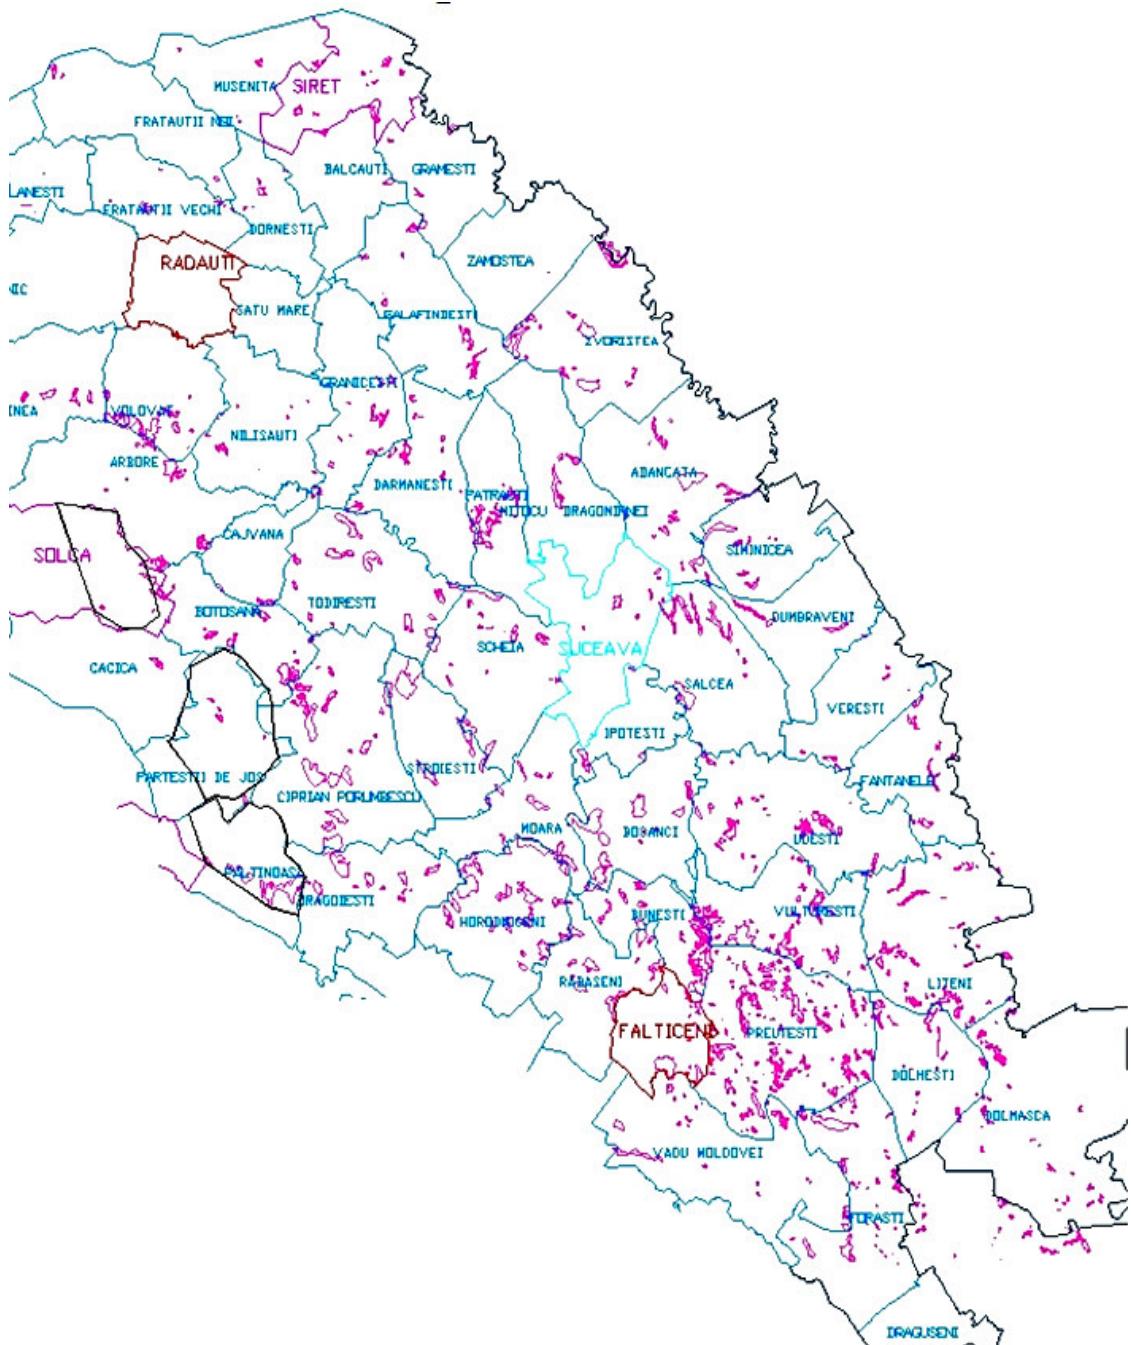
Fig. 2. Spatial distribution of soil damage perimeters in the study area.

The most intense soil degradation processes have been encountered in overgrazed pastures, especially related to soil loss and land displacement, related mostly to clay or sandy substrates. Overlaying the degradation forms map on the map of administrative units, a spatial pattern of distribution can be observed: the highest percentage of land damage is located in the south and south east part of the study area, followed by the central area (fig. 2). These areas also present a high intensity of land degradation processes, with rapid evolution towards non usable land.

The intense fragmentation of some perimeters shows the possibility that the entire area surrounding these degradation perimeters could be facing the same degradation problems. The delineation took into account only the forms that can be identified by visual analysis on the aerial photo, without using previous information about the field parameters. The form of each soil damage zone could also indicate the general type of the preponderant degradation process (liniar forms are usually related to gully erosion, compact zones are characteristic for landslides).

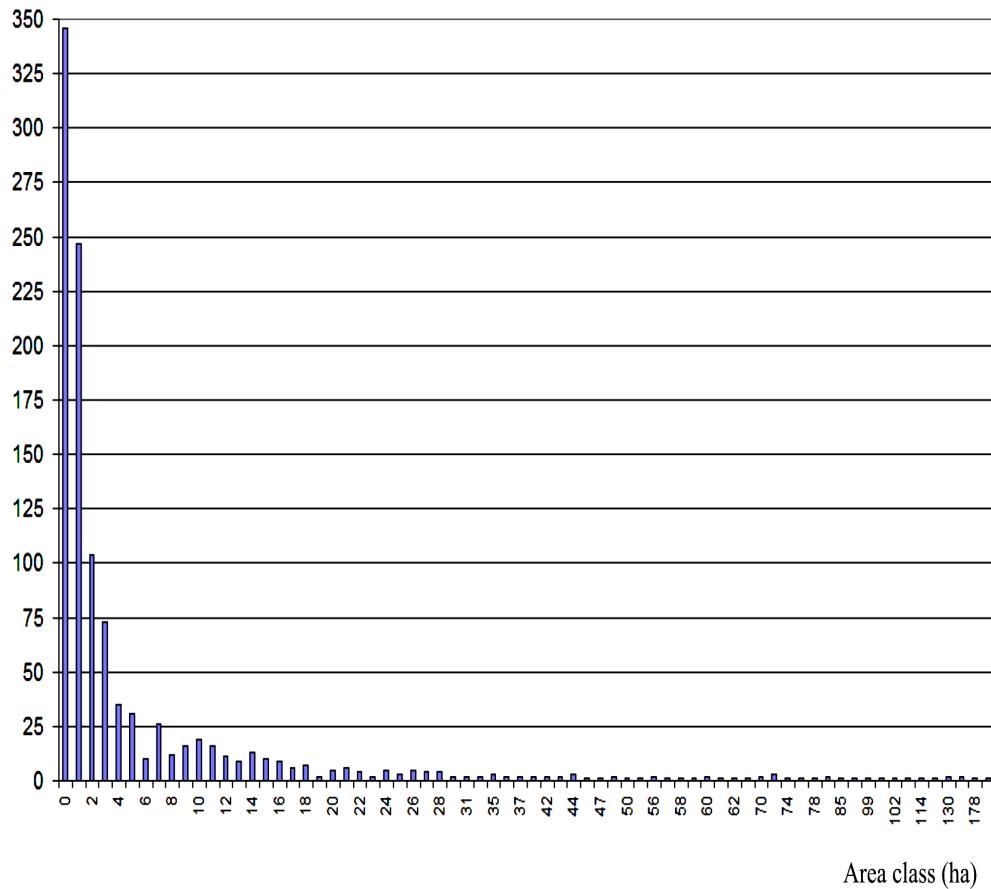
Fig. 3. The distribution of degradation perimeters on area classes

The dimensions of the degradation areas are also important in assessing the intensity and the exposure to catastrophic events. Analyzing the distribution of degradation perimeters on area classes (fig. 3), we can notice that most parameters are found in low area classes. The problem is that, on the other end of the distribution, we can find a various number of zones with a very high area with degradation processes (the maximum area of a degradation zone is about 180ha). This fact raises serious problems regarding the designing of the ecological rehabilitation procedures, due to the large area and the variability of soil and hydrological parameters. As wise, the small perimeters represent usually soil degradation initiation zones for major erosion or land displacement phenomena and an early intervention would considerably decrease the costs of damage control and ecological reconstruction.
